CRITICAL AREAS REPORT

Revised August 2, 2022

Mid I-5 Industrial Park Kelso, Washington

Photoplate 1 Site Photos

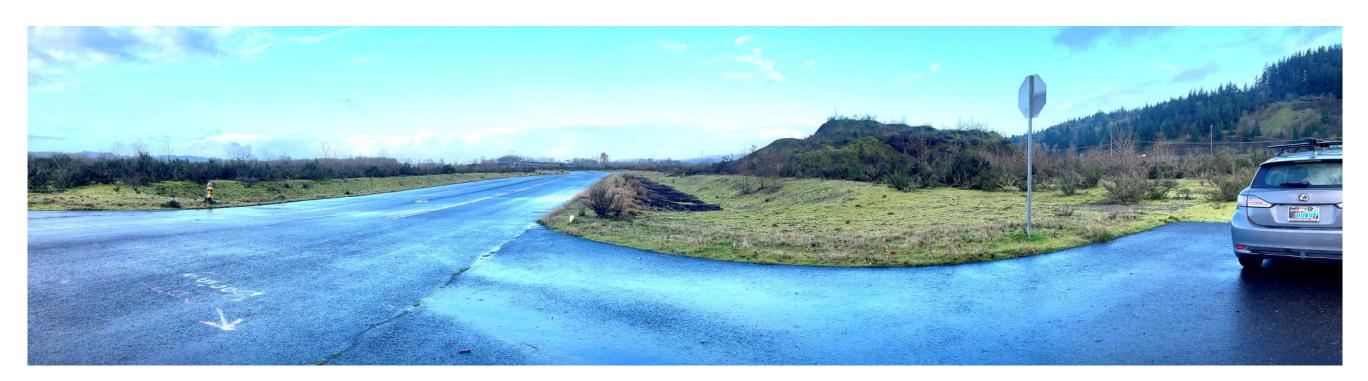
Photo 1: Southern end of Talley Way facing north in the central portion of the study area.

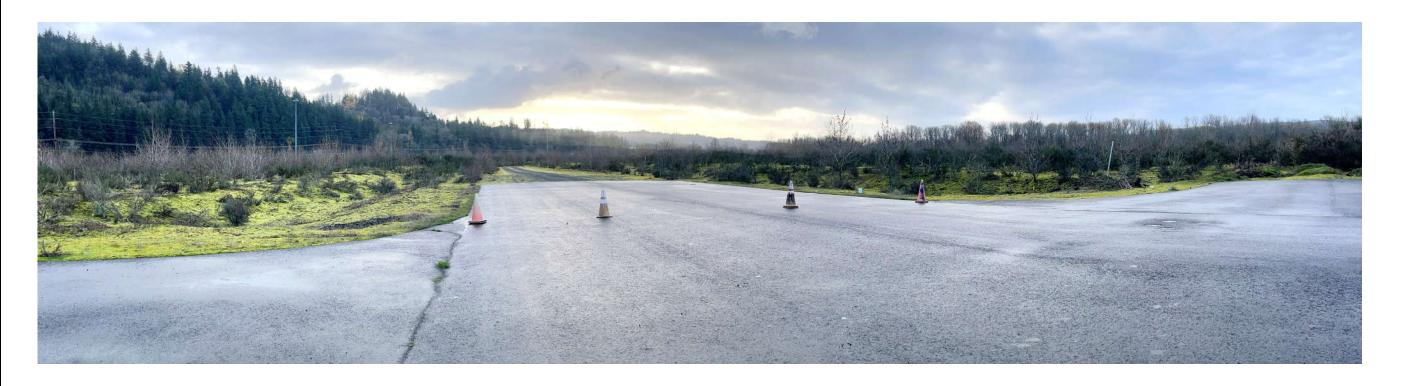
Photo 2: Southern end of Talley Way facing south in the central portion of the study area.

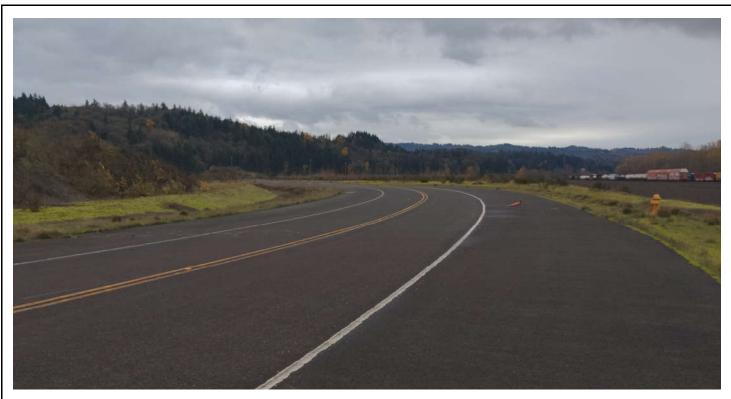
Photo 3: Northern end of Talley Way facing south at the northern end of the study area.

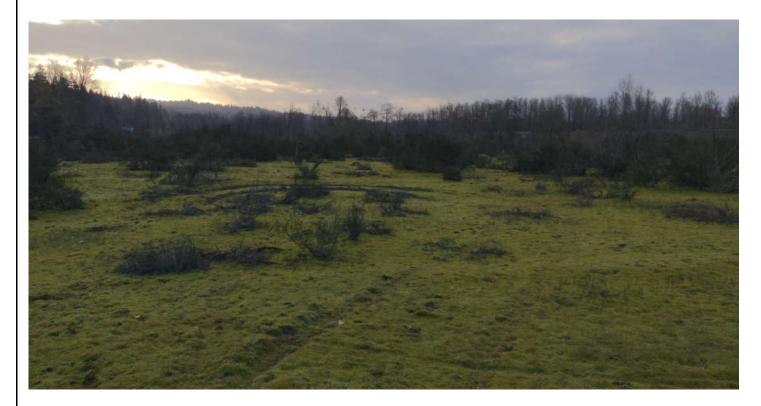
Photo 5: Overall representative upland photo in southern portion of the study area facing southwest. Trees pictured in center right are offsite along a railroad berm.

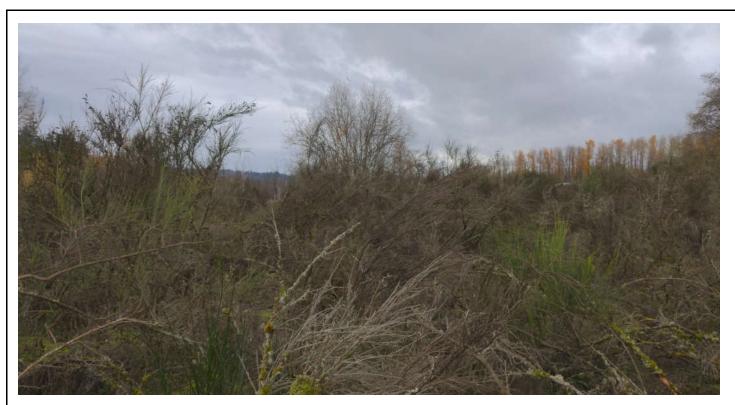
Photo 6b: Facing south from the same location as Photo 6a. The row of trees in the central right are offsite along a railroad berm. Photo 6d: Facing north and upslope from the same location as Photo 6a.

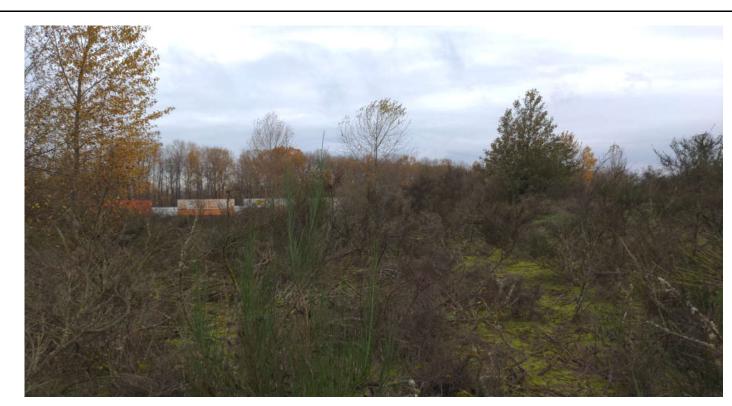
Photo 6c: Facing west from the same location as Photo 6a. Railroad cars are visible on track offsite. Photo 7: Facing north from TP-13 located in the central portion of the study area.

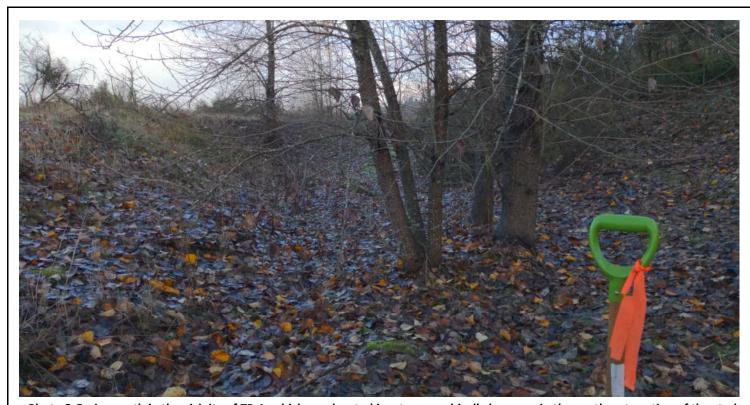
Photo 8: Facing north in the vicinity of TP-1, which was located in a topographically low area in the southeast portion of the study area.

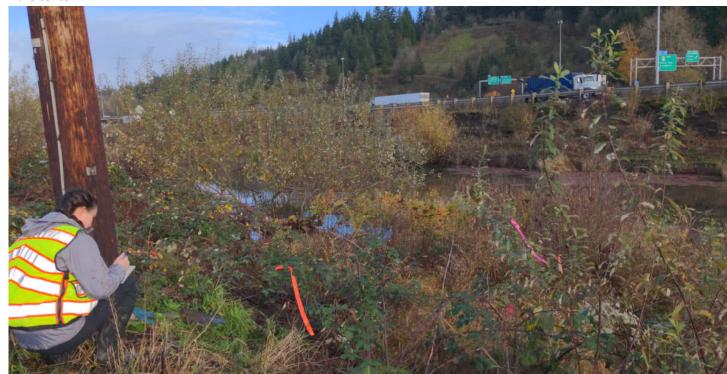
Photo 10a: View looking northeasterly at TP-8 located on the fill slope of the utility pole. The I-5 southbound onramp is visible across the center.

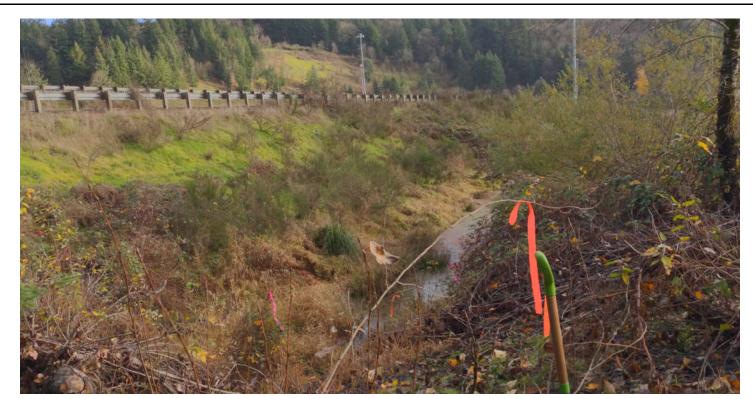
Photo 9: Facing southeast at the northeastern finger of Wetland A. TP-10 is visible in the foreground. TP-9 and a wetland flag are visible downslope.

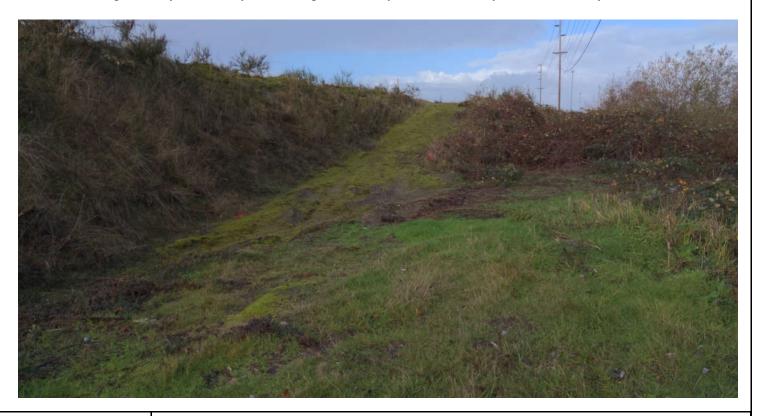
Photo 10b: Looking northerly at the utility access along the eastern portion of the study area in the vicinity of TP-8.

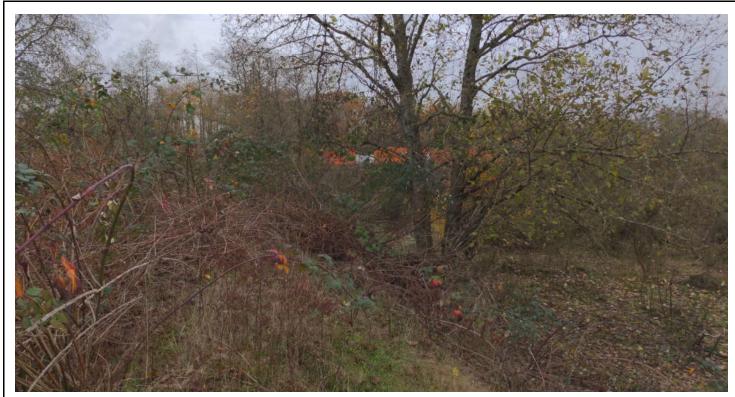
Photo 11a: Facing west from the berm along the southern fill boundary, upslope of TP-4. Vegetation generally consists of blackberries, Scot's broom, and occasional alder trees.

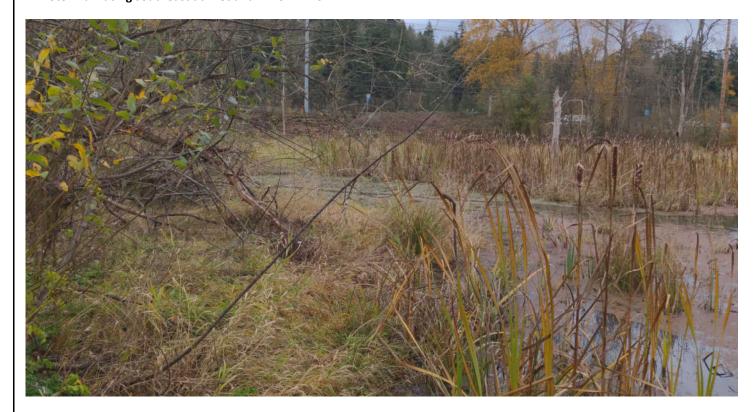
Photo 12a: Facing southeast at Wetland A from TP-3.

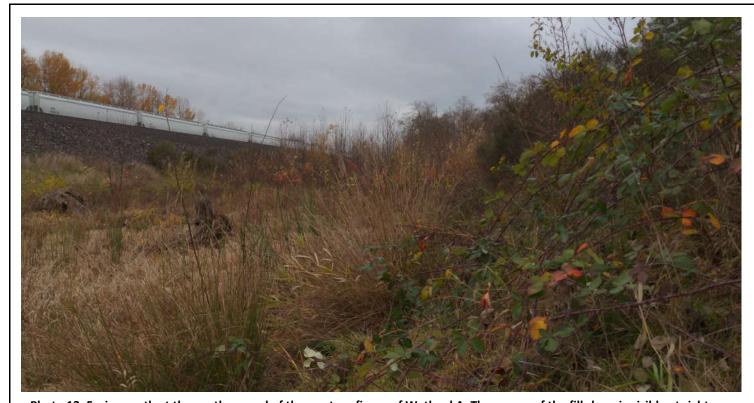
Photo 13: Facing north at the southern end of the western finger of Wetland A. The corner of the fill slope is visible at right.

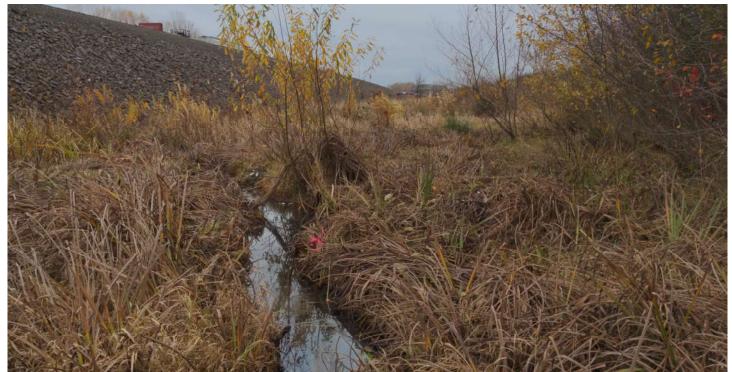
Photo 14: Facing north at the western finger of Wetland A from TP-5. TP-5 is located on fill approximately 4 feet higher than Wetland A.

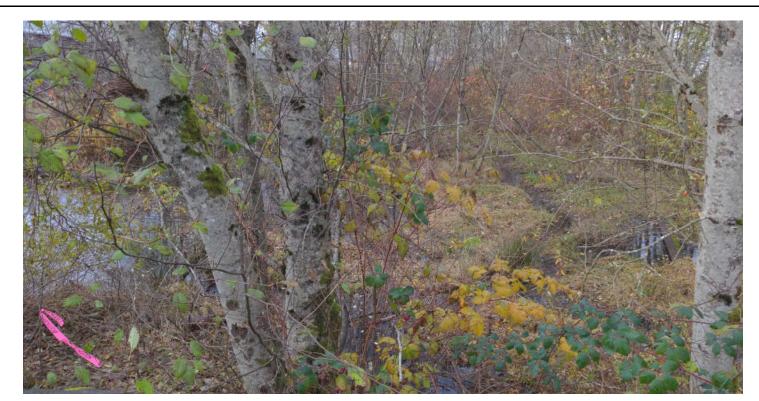
Photo 16: Facing north at the central portion of the western finger of Wetland A that contains permanent water.

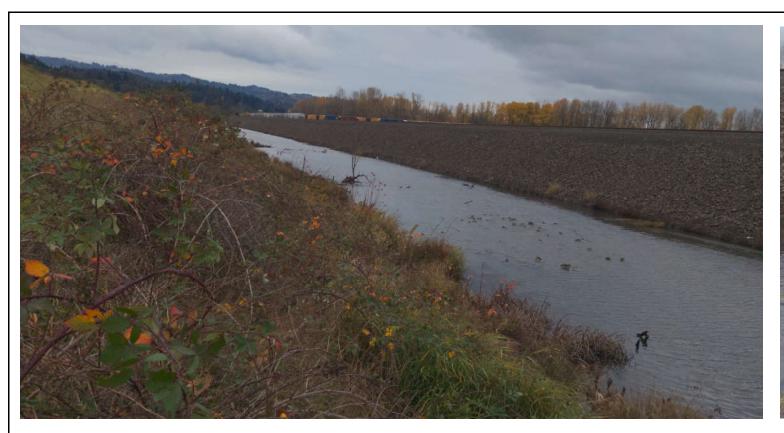
Photo 17a: Facing south from the northern portion of the western finger of Wetland A. Limited vegetation is present on the fill slope.

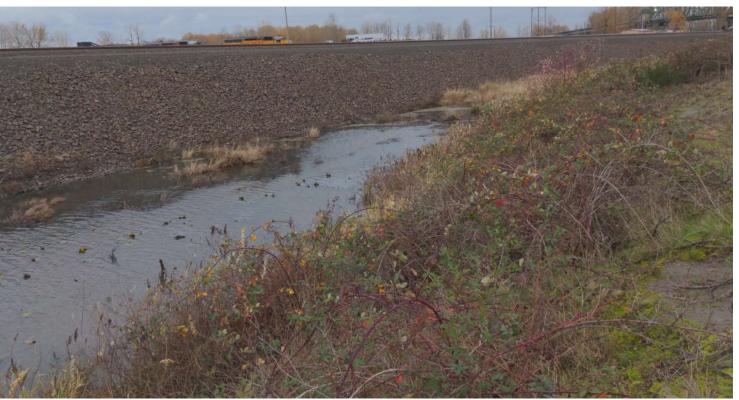
Photo 17b: Facing north from the same location as Photo 17a. Permanent flooding transitions to seasonal flooding near the light brown vegetation pictured in the upper right.
