# **CRITICAL AREAS REPORT & BUFFER RESTORATION PLAN**

**Valentina's Villas**

**September 16, 2024**

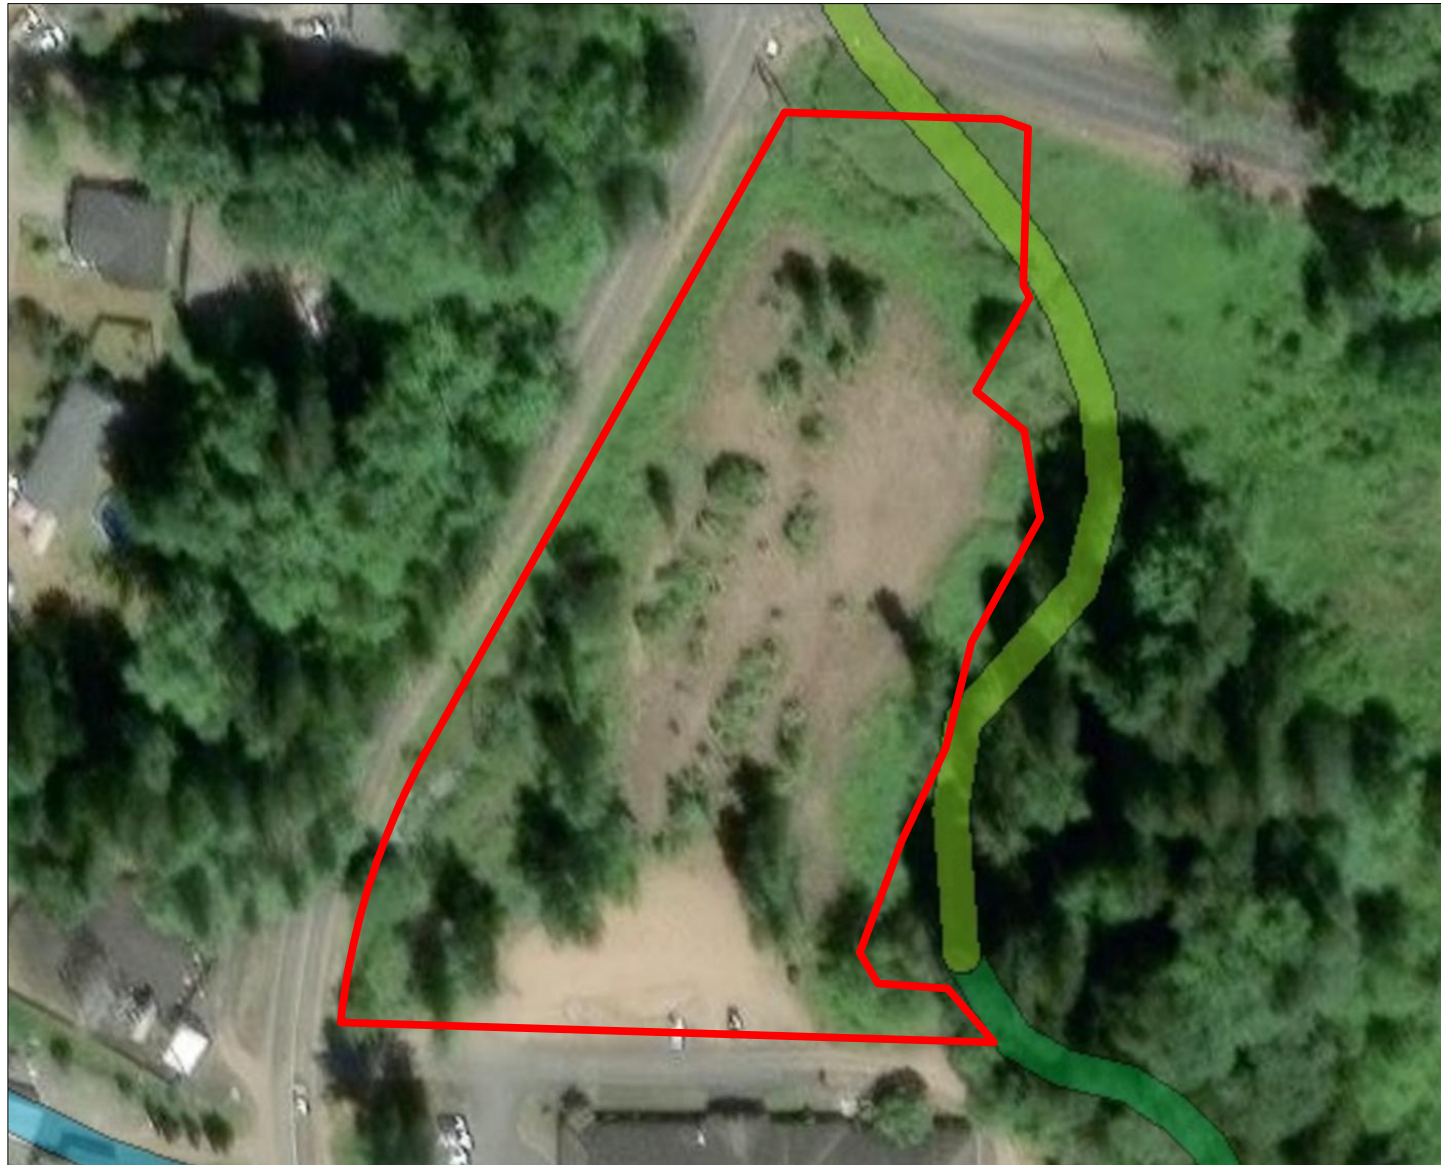
**PROPOSED:** XX  
Add 2  
**IN:** Kelso  
**NEAR:** XX  
**COUNTY:** Cowlitz **STATE:** WA  
**FIGURE:** 3  
**DATE:** 9-13-24

A narrow wetland corridor is mapped offsite to the east and northeast sections of the subject parcel by the National Wetland Inventory (NWI). NWI maps Freshwater Emergent Wetland in the northeastern section of the subject parcel (Figure 3). AES observed that the NWI mapping actually represents the defined stream channel onsite with no fringe wetlands present. AES did however observe slope wetland north of the stream channel in the far northeastern portion of the subject parcel.

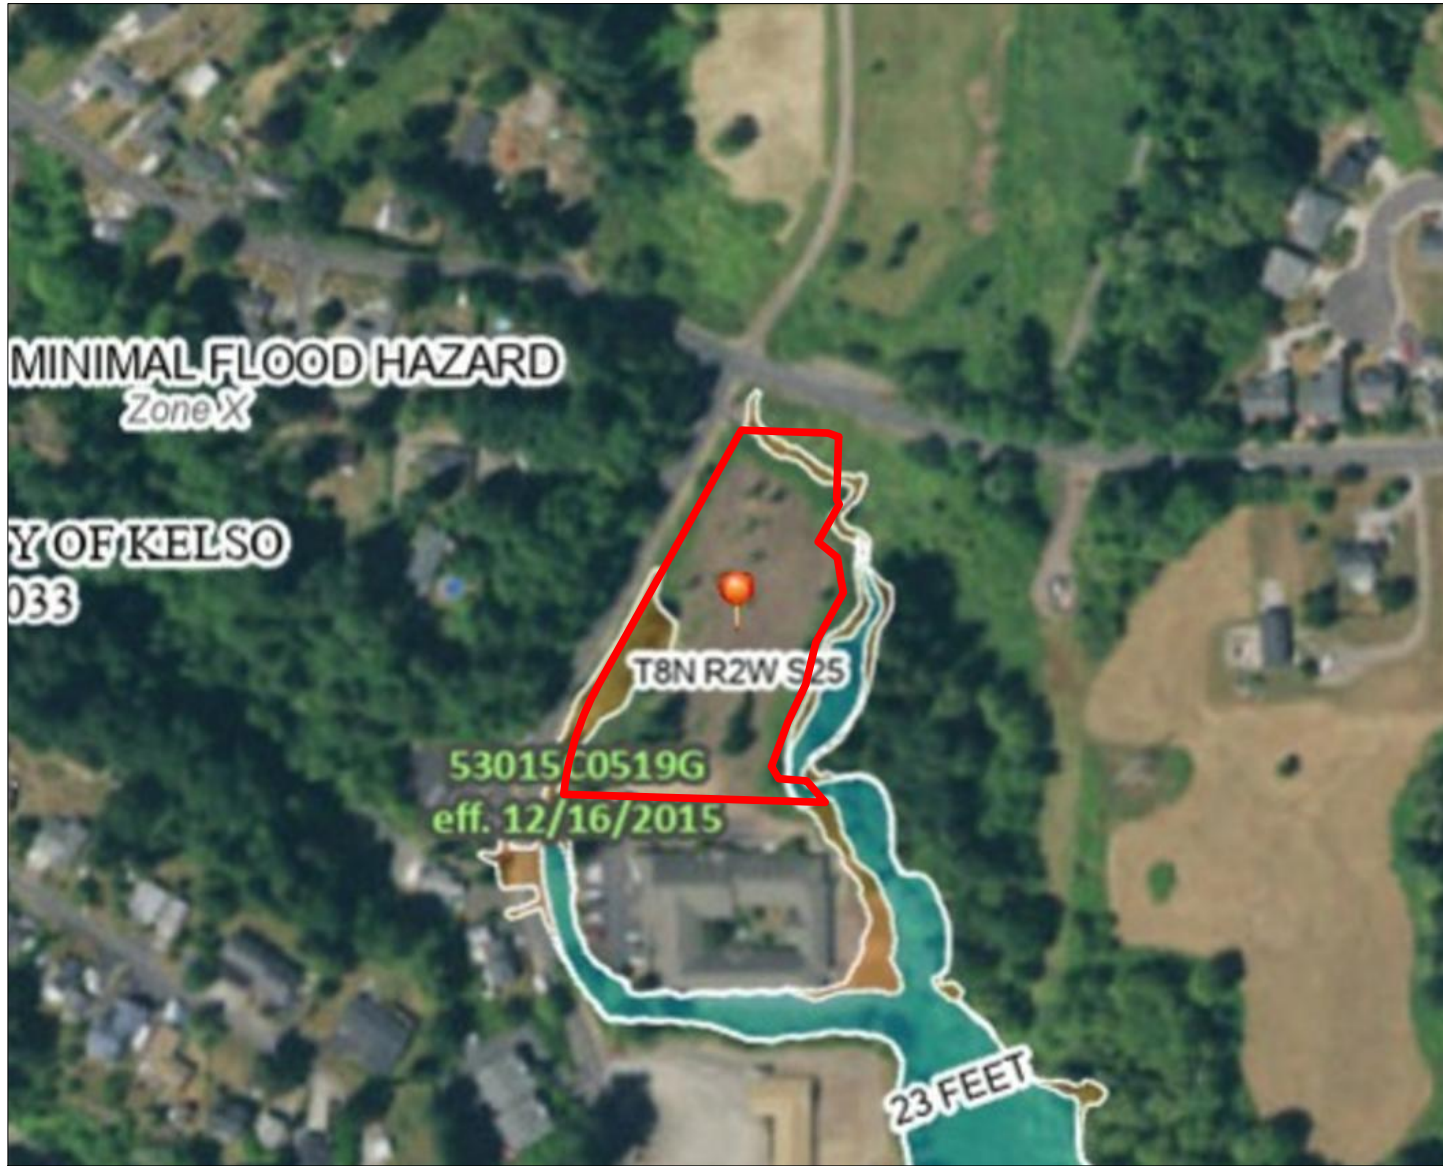
**PROPOSED:** XX  
Add 2  
**IN:** Kelso  
**NEAR:** XX  
**COUNTY:** Cowlitz **STATE:** WA  
**FIGURE:** 6  
**DATE:** 9-13-24

Federal Emergency Management Agency (FEMA) regulated floodplain is mapped in association with the Coweeman River south and east of the subject site. The mapped floodplain does not extend west of the stream channel onsite (Figure 6). Regulated Floodplain is generally referred to as the land area susceptible to inundation/flooding during the 100-year recurrence interval defined as the one percent (1%) chance that a flood of that magnitude, or greater, will inundate susceptible land in any given year. The limit of the 100-year flood susceptible land area is based on federal and/or local jurisdiction flood maps. The susceptible land must remain relatively free from obstruction so that the 100-year flood can be conveyed downstream.

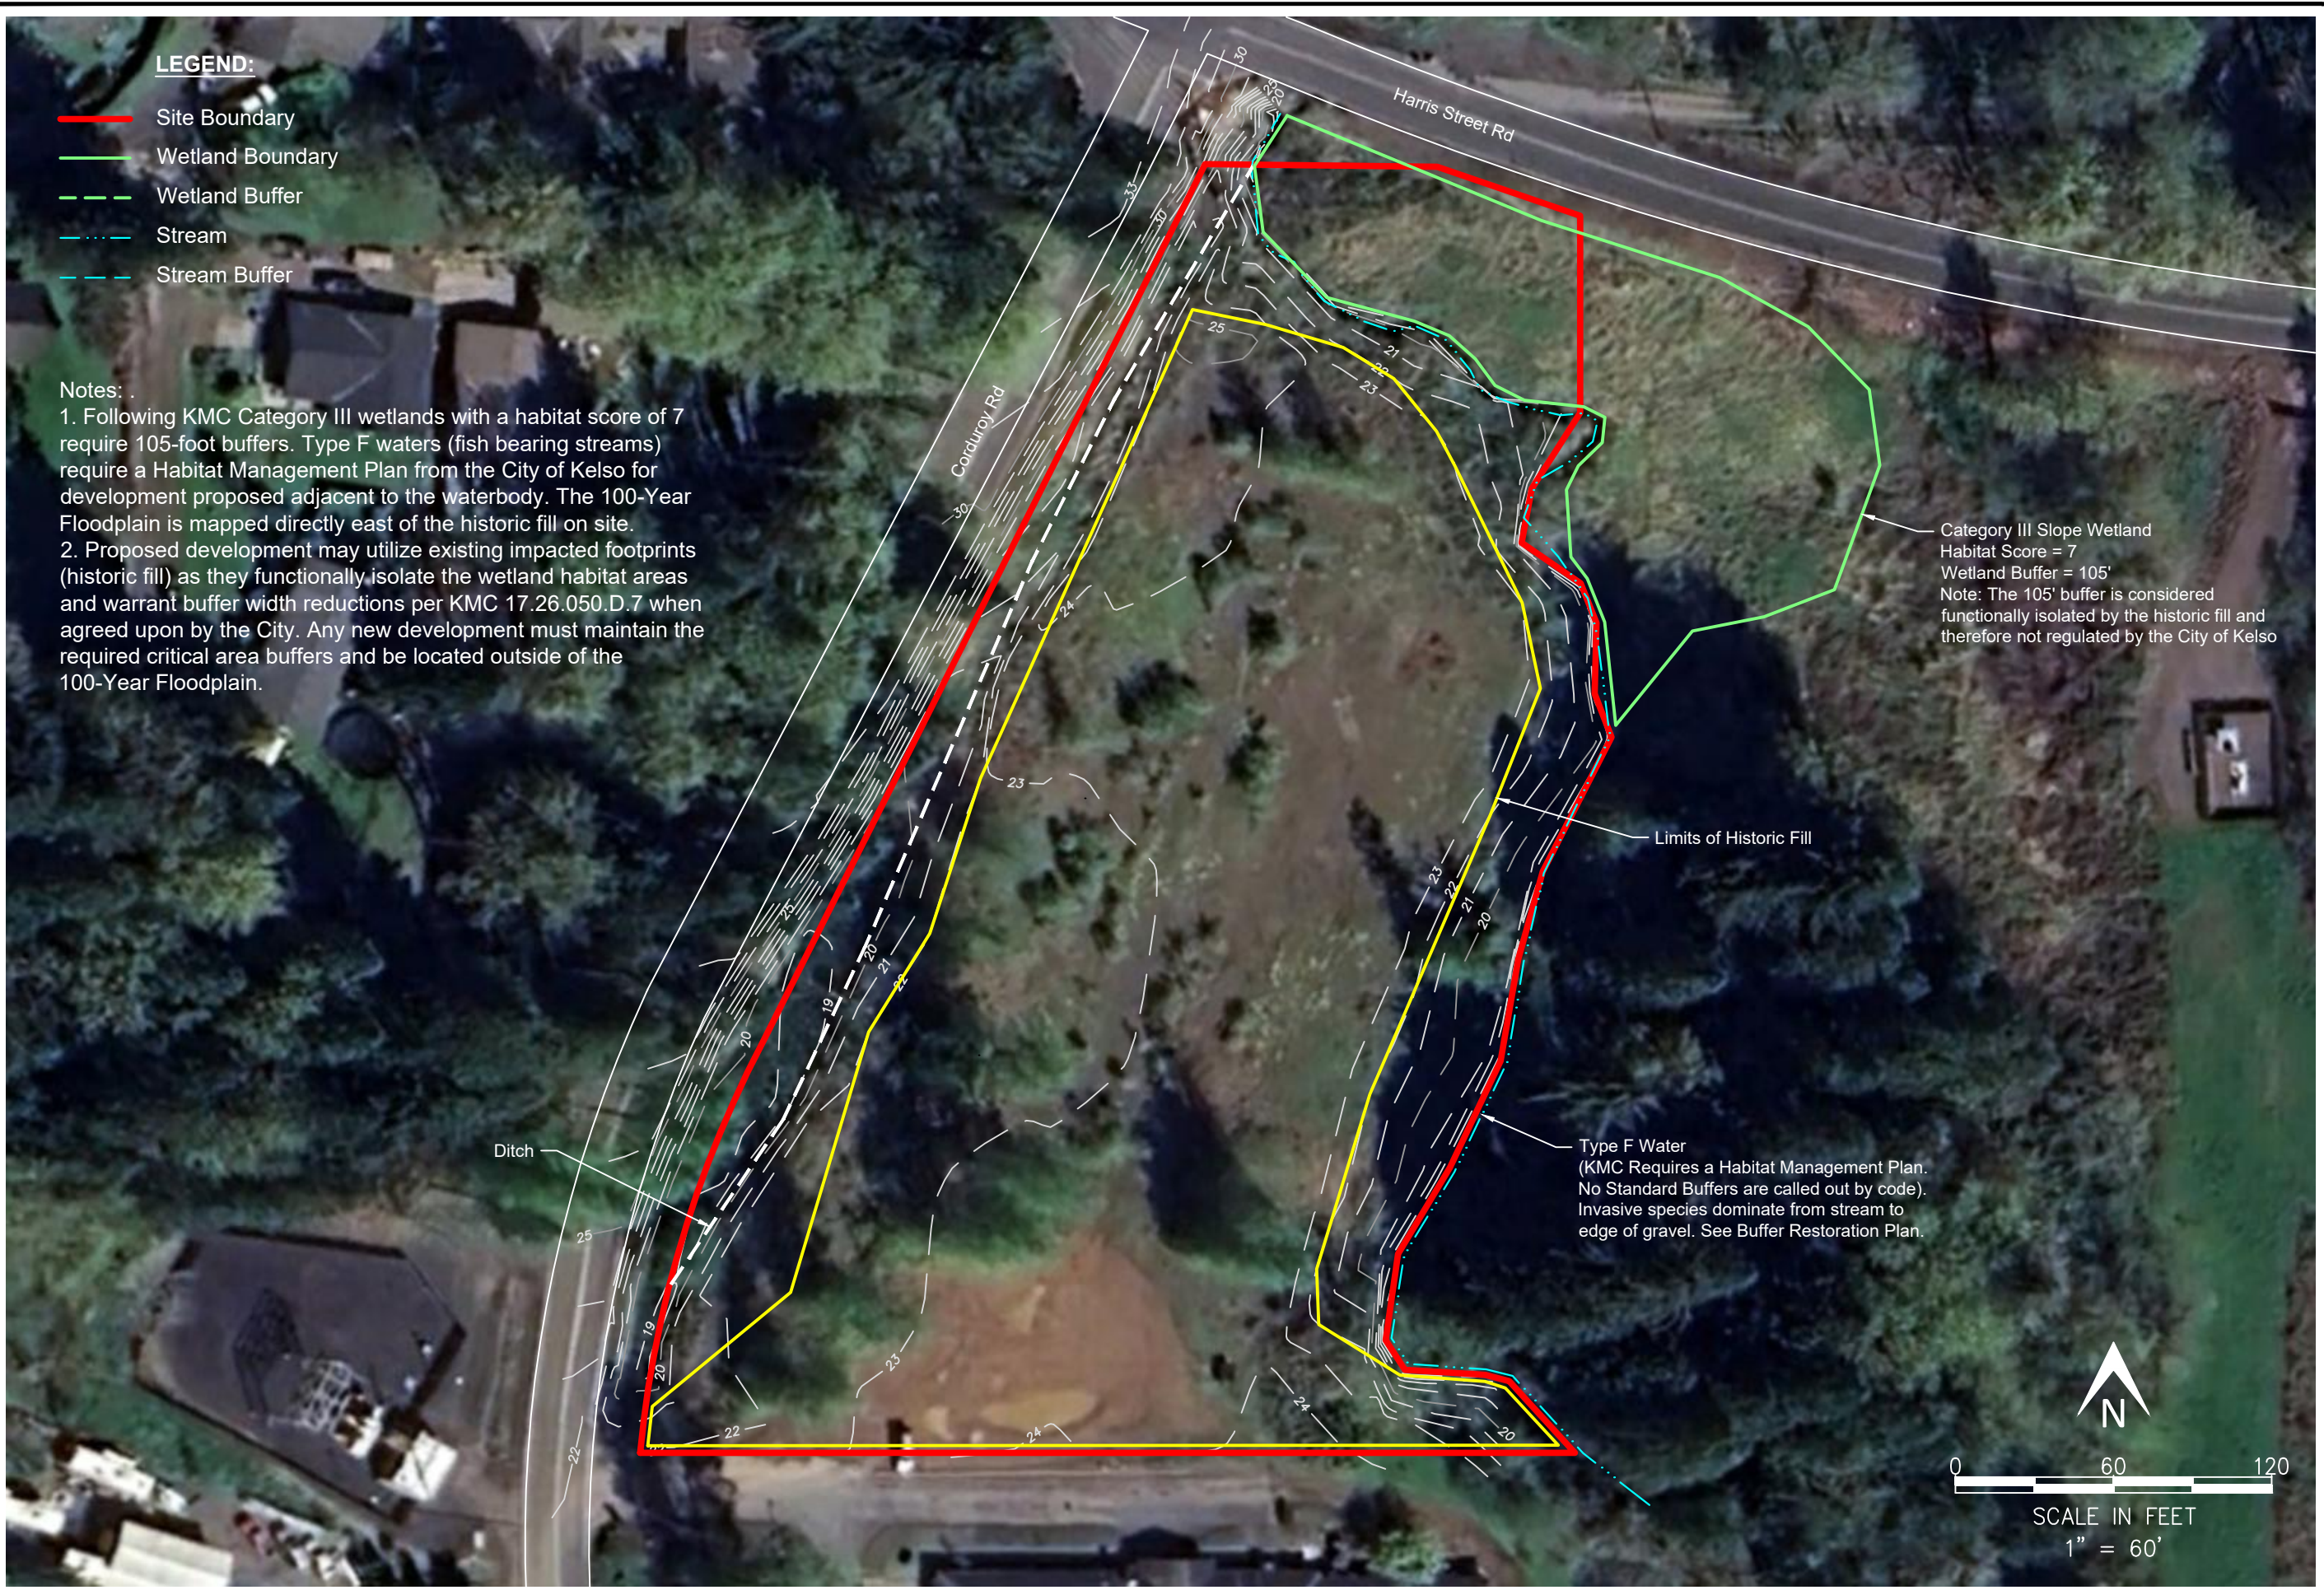
The subject parcel was evaluated for the presence of wetlands using the Routine Determination Method per the U.S. Army Corps of Engineers' (USACE's) *Wetland Delineation Manual* (1987), the *Washington State Wetlands Identification and Delineation Manual* (1997), and the *Regional Supplement to the Corps of Engineers Wetland Delineation Manual: Western Mountains, Valleys, and Coast Region, Version 2.0* (USACE 2010). The Routine Determination Method examines three parameters to determine if wetlands exist in a given area: vegetation, hydrology, and soils. The presence of hydrology is critical in identifying wetlands; however, since hydrologic conditions can change periodically (hourly, daily, or seasonally), it is necessary to determine if hydrophytic vegetation and hydric soils are also present. By definition, wetlands are those areas that are inundated or saturated by surface or ground water at a frequency and duration sufficient to support, and that under normal circumstances do support, a prevalence of vegetation typically adapted for life in saturated soil conditions. Wetlands are regulated as "Waters of the United States" by the USACE, "Waters of the State" by Washington State Department of Ecology (ECY), and locally by KMC Chapter 17.26.050 Wetlands. Wetlands were identified onsite north of the stream channel within the northeastern limits of the subject parcel (Figure 8).

The methodology used for determining the location of the ordinary high-water mark (OHWM) of the Type F stream followed the Washington State Department of Ecology's (ECY) *Determining the OHWM on Streams in Washington State* (2010). AES delineated the onsite OHWM of the stream as depicted on Figure 8.

DNR identifies the unnamed stream that occurs along the eastern parcel boundary and within the northern section of the subject parcel as a Type F Water (fish bearing), (Figures 4 and 8). The Type F Water meets the "Class 5" water classification listed by KMC 17.26.060. KMC does not identify a standard buffer width for Class 5. However, KMC does recommend the development of a Habitat Management Plan as deemed necessary for the project under review or habitat type.

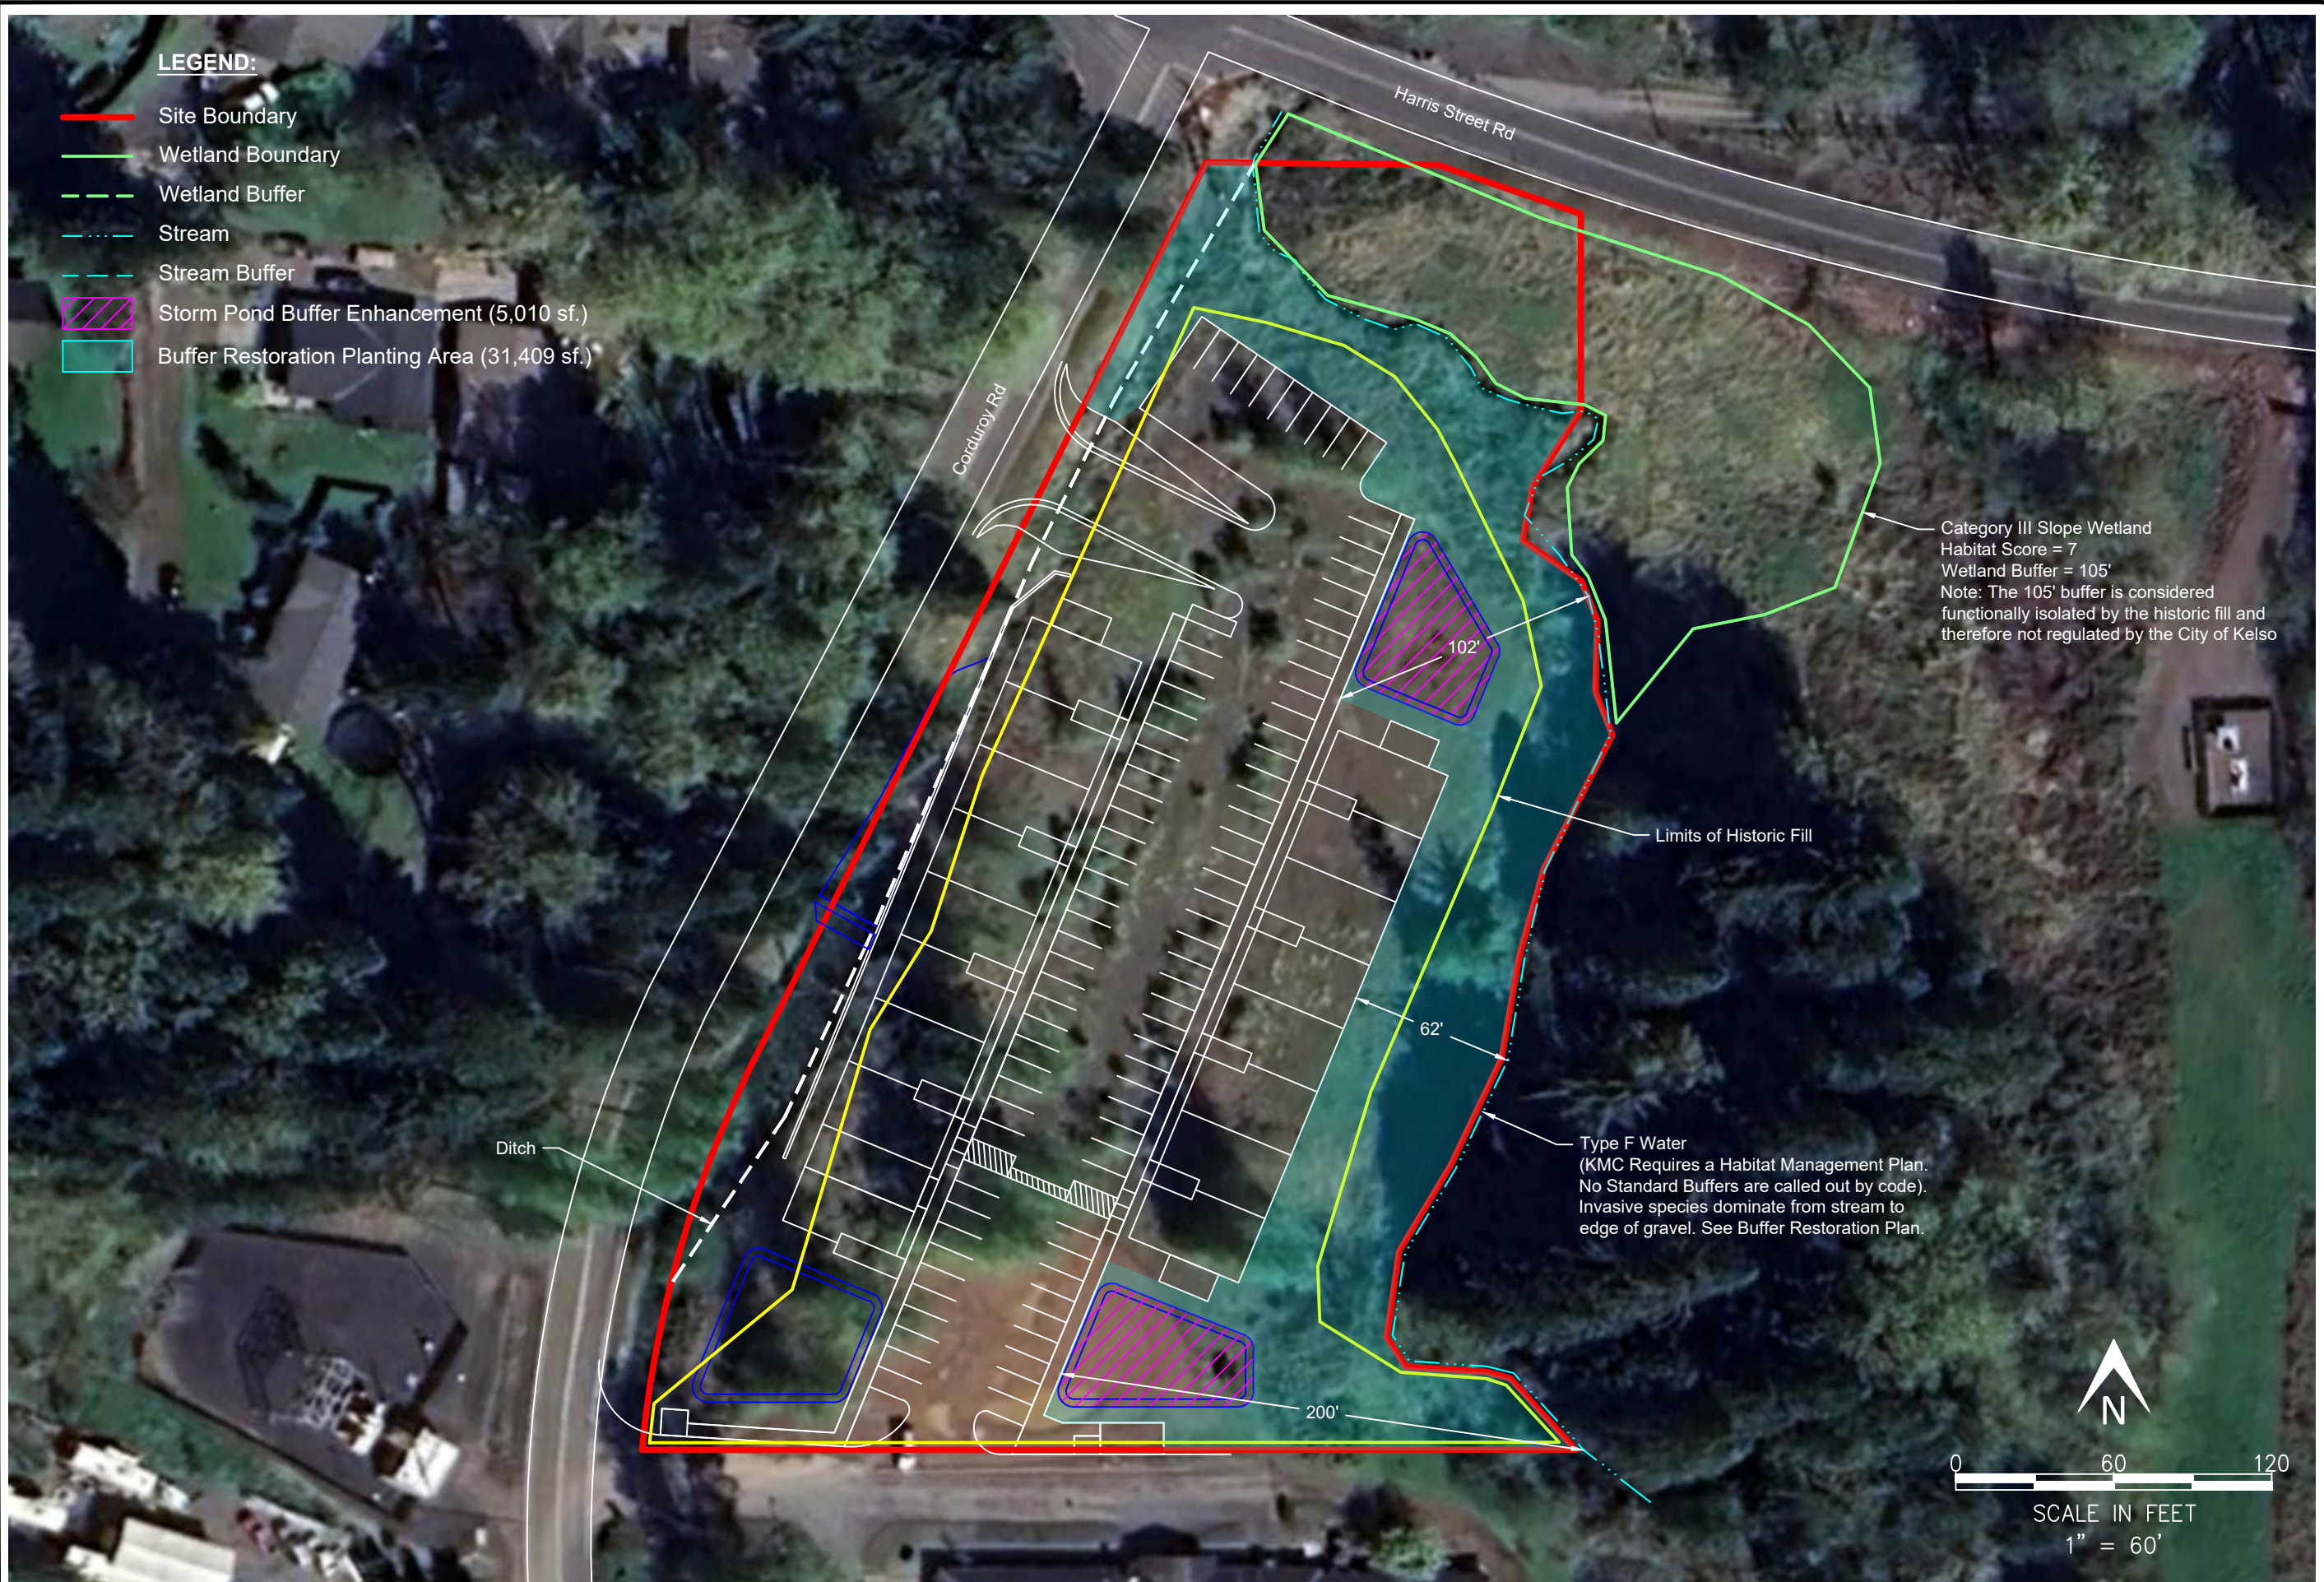
The subject parcel is highly constrained due to its configuration and the wetland and riparian habitat that flanks it. The applicant proposes the construction of an apartment complex (Valentia's Villas) within the central upland and historically graded area of the site, while avoiding new impacts to the onsite critical areas (Figure 9). By utilizing the limits of the existing graded area, the proposed project will result in no net loss critical area habitat functions or values, as no new impact to onsite critical areas are proposed. The proposed project has been designed to concentrate high traffic areas, such as access and parking, within the central area of the apartment complex and all runoff off from paved areas will be treated onsite within engineered stormwater facilities.

The existing critical area buffer habitat onsite is sparsely vegetated and/or dominated by invasive species that do not perform the adequate functions required to protect the onsite critical areas. The project proposes a buffer restoration plan to provide the appropriate native plant community that will perform the functions needed to protect the onsite critical areas. The buffer restoration area proposed will total 36,419 sq. ft. of area and consist of 31,409 sq.ft. of riparian/wetland buffer restoration as well as 5,010 sq.ft. of storm pond enhancement also located within the onsite buffer habitat. The proposed buffer restoration area has areas of overlapping wetland and riparian buffer habitat and will provide an average native vegetated buffer width of 121-feet, Figure 9. In addition to the native tree and shrub installation, the invasive species will be removed. The proposed stormwater pond buffer plantings will consist of native emergent species ideal for the depressional areas anticipated to be saturated during the wet season, with native trees and shrubs added to the outer perimeter areas where growth won't impede on the constructed ponds. The addition of native trees and shrubs to the perimeter of the stormwater ponds will provide for a contiguous vegetated habitat buffer and provide shielding, shade and shelter functions to the adjacent Type F water above that historically present.

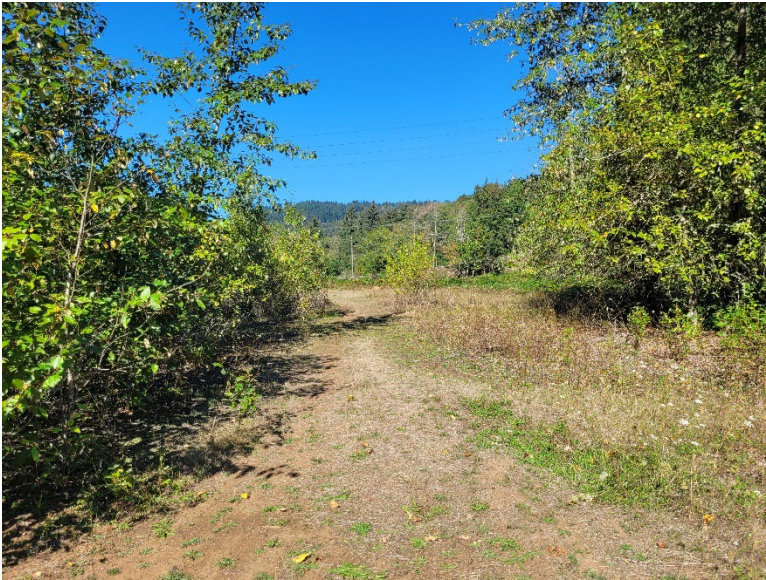
**Photo 1.**

View of the site entrance near the southern property boundary.

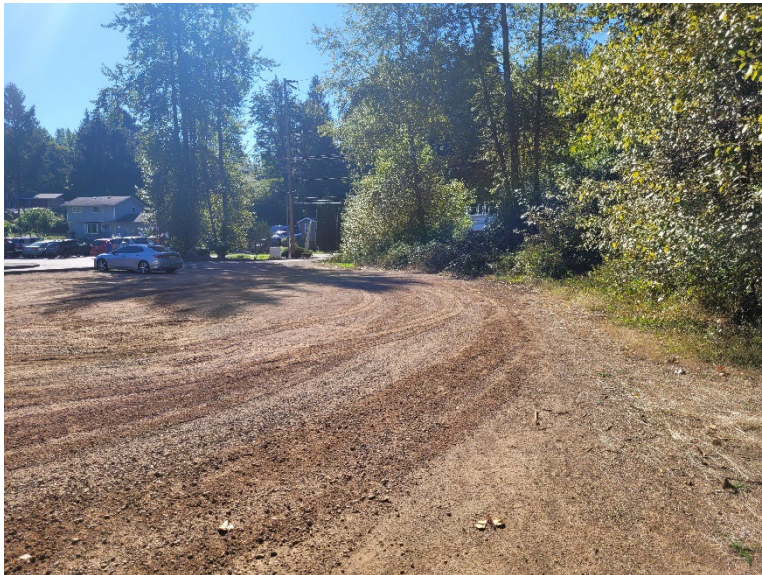
**Photo 2.**

View west over the existing access present for the adjacent property to the south (Highlander Place, - assisted living facility). The existing improved driveway is located just north of the car in photo. The open dirt area is the southernmost portion of the subject site where parking and the southern site access is proposed by the site plan.

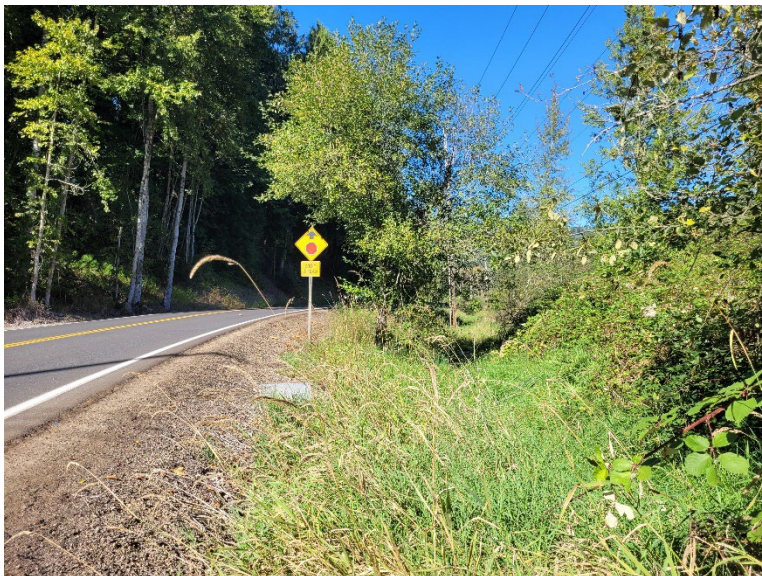
**Photo 3.**

View north down the roadside ditch present east of Corduroy Road.

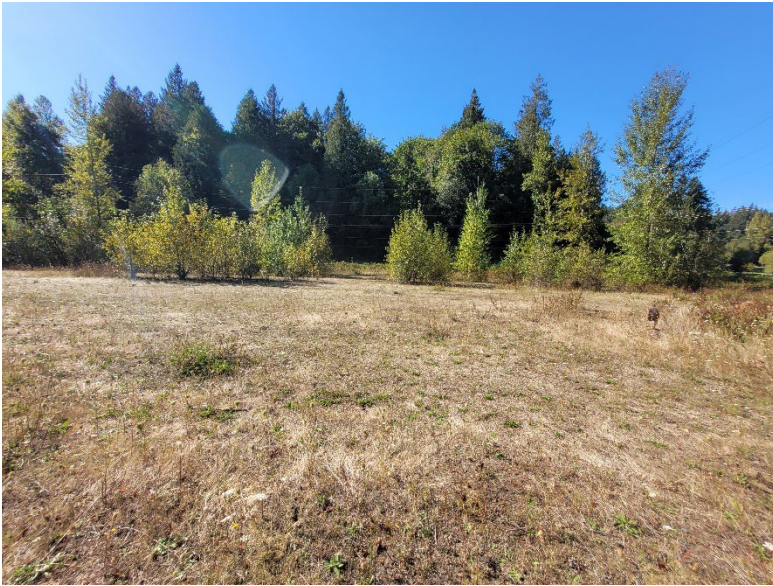
### **Photo 4.**

View west over the central portion of the subject parcel. The open area visible in the foreground represents the historic graded and graveled footprint onsite to be utilized by the proposed project. Scattered black cottonwood saplings have seeded in along the western side of the parcel.

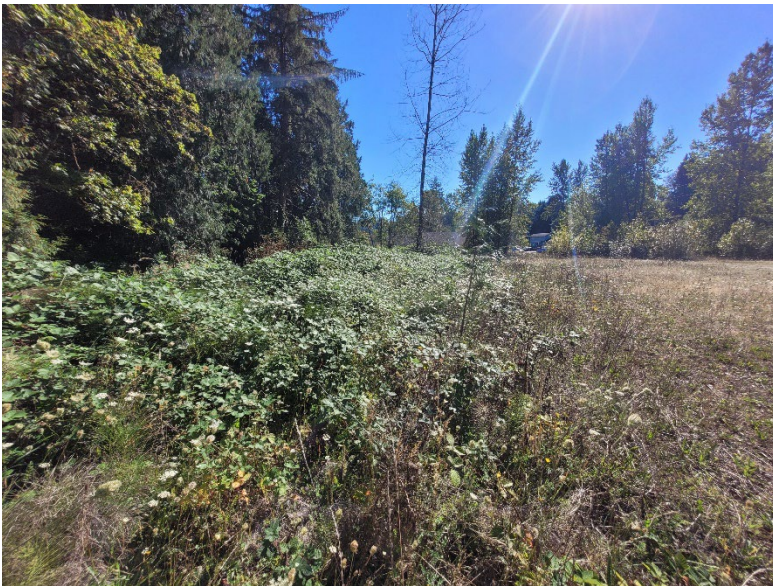
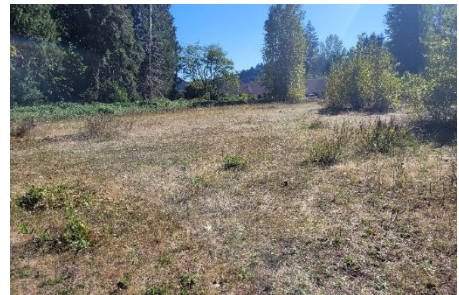
### **Photos 5a, 5b.**

5a) View south down the eastern limits of the subject parcel. The forested trees visible in photo are located directly off site and east of the stream channel present in this area. The dense H. blackberry visible at left of photo represents the degraded riparian buffer historically present onsite. 5b) View south down central portion of site.

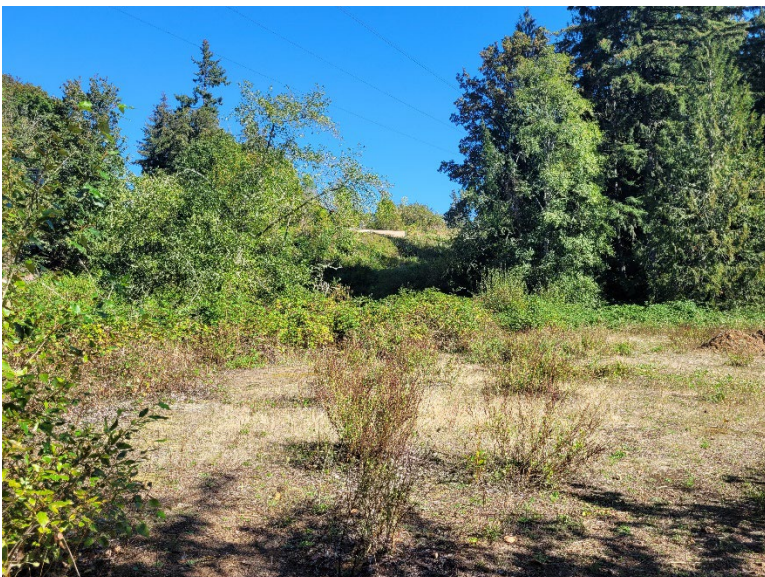
### **Photo 6.**

View east across the north/northeastern extent of the graded footprint onsite. The forested trees visible in photo are located directly off site and east of the stream channel present in this area. The dense H. blackberry visible in middle of photo represents the degraded riparian buffer historically present onsite. The buffer restoration plan proposes to upgrade the onsite buffer habitat by removing invasive species and installing native tree and shrub cover.

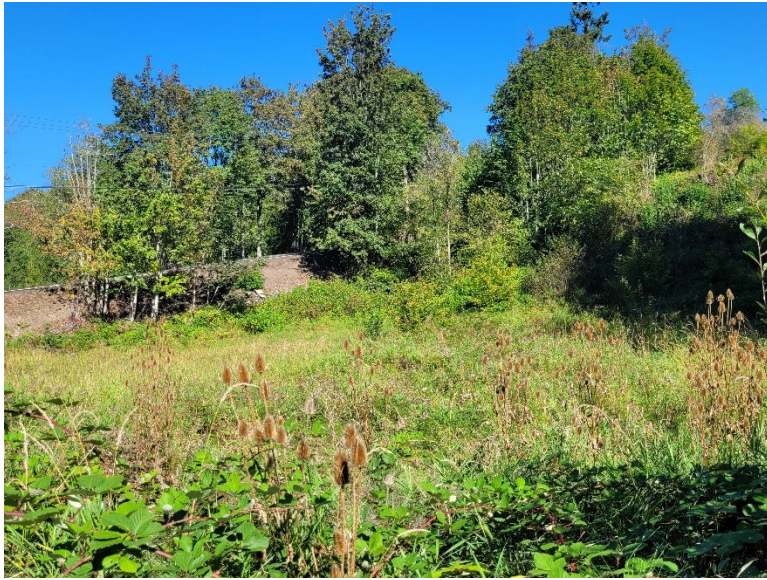
### **Photo 7.**

View over the wetland present in the north/northeastern portion of the subject site and north of the stream channel. The wetland is dominated by reed canarygrass. The stream channel is not visible in photo, but the dense H. blackberry visible at bottom of photo represents the degraded southern riparian buffer historically present onsite.

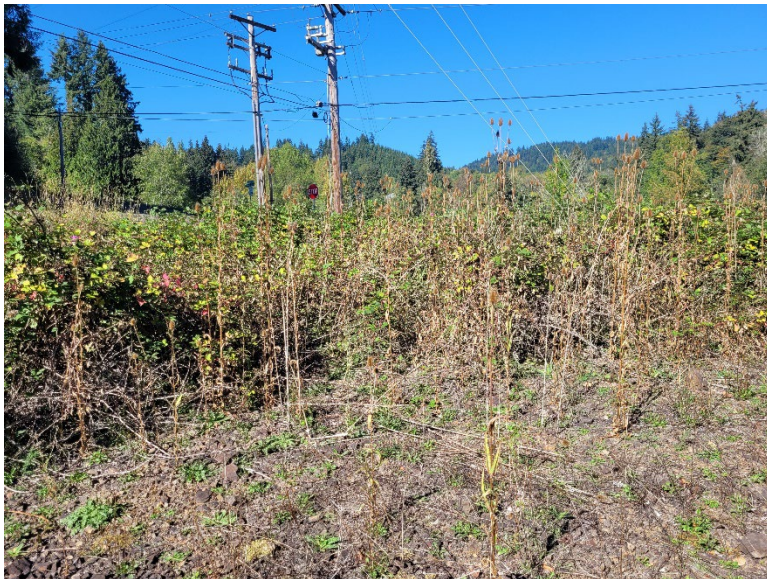
### **Photo 8.**

View north across the north/northwestern extent of the graded footprint onsite. Angular gravels are present within the historically graded area, hence the lack of vegetation. The vegetation present directly north (along the stream channel) is dominated by H. blackberry.

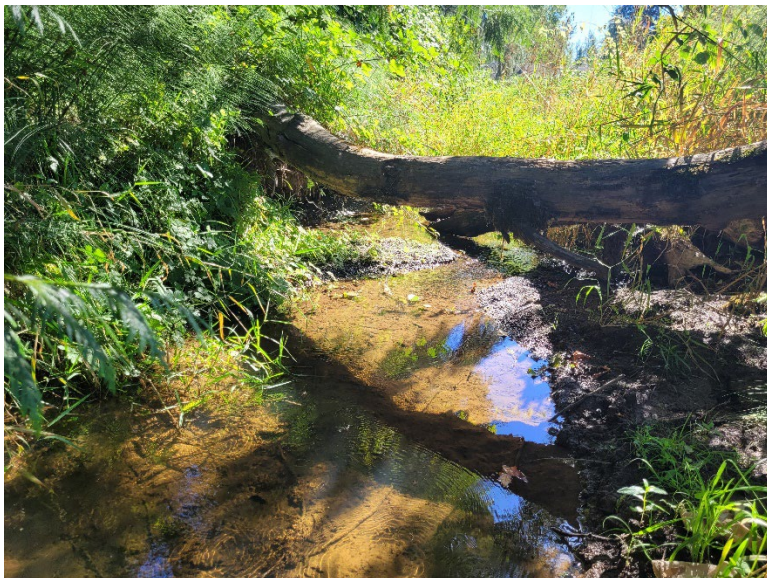
### **Photo 9.**

View south down the Type F stream channel present onsite. The buffer is degraded and lacks native vegetation. The buffer restoration plan proposes to upgrade the onsite buffer habitat.
